Duplex home Armada St, Bayswater Western Australia

RENOVATION

Renovation completed in 2004

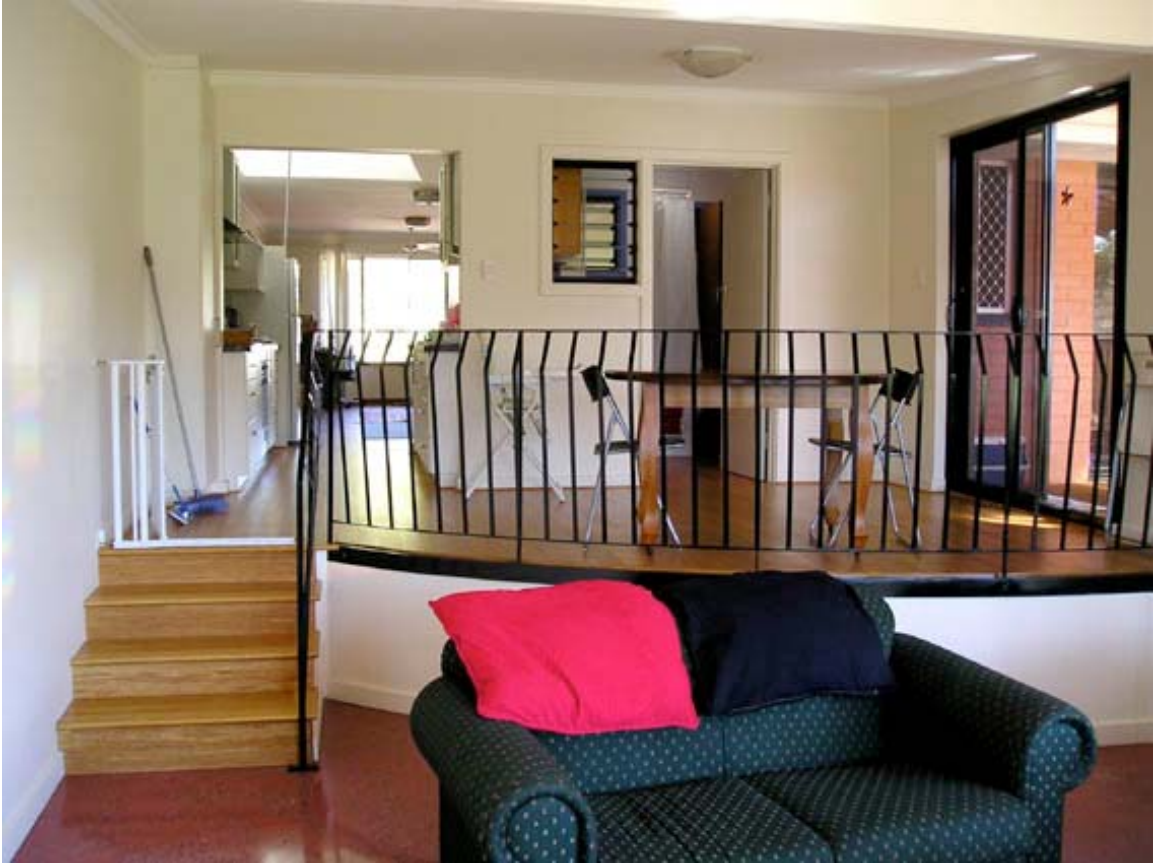
A pleasant split level, well lit living room.

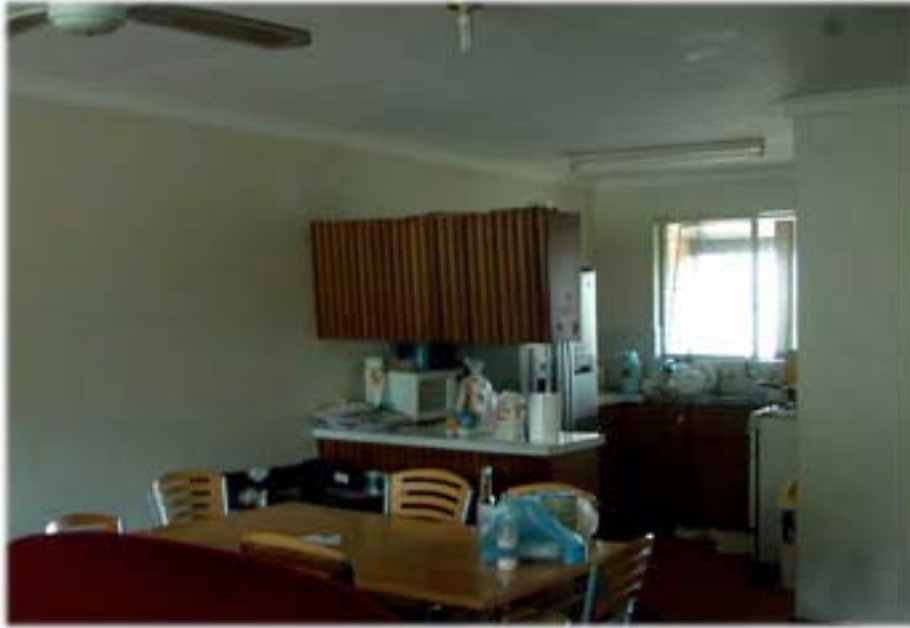
Adjoining duplex half showing only source of natural light to rear.

Both sides of the duplex were a mirror image of each other. There was no connection between the indoor and outdoor areas. The living area and kitchen were dark. The laundry, toilet and bathroom and a small back verandah prevented warming winter sun entering our home. There is significant embodied energy in the brick and concrete structure that already existed and the owners wished to preserve this. The aim was to

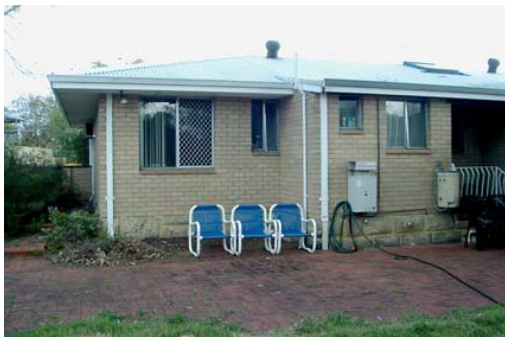
Original style of rear – typical 1960s home with bathroom to north.

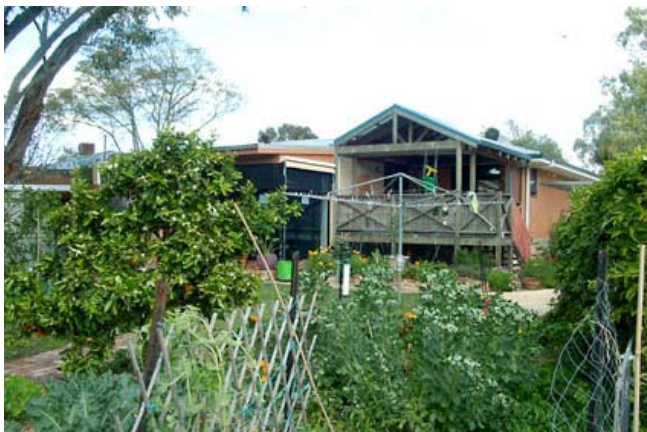
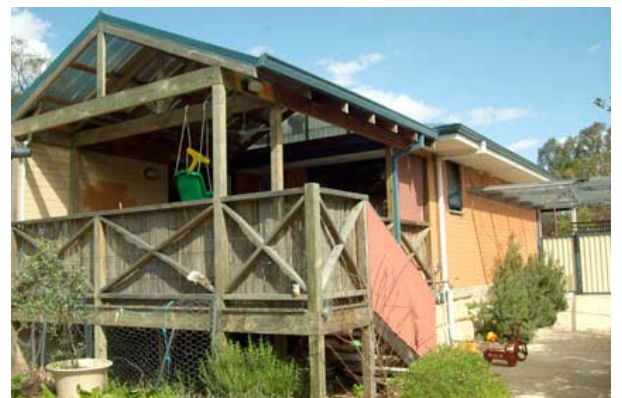
Creative use of height – outdoor deck area, no re-location of bathroom needed.

capture as much north winter sun as possible given the north eastern aspect of the building. The easiest way to achieve this was to build out from the existing concrete slab (the stairs are the old stairs leading off the back verandah) and open up the room with a large bank of windows. It was important that the windows provide good cross ventilation, particularly at night. Louvres with security bars and insect mesh have been an excellent investment. Our deck provides us with a warm place to sit in winter and another living area.
